**BP4: Specified Highway Remedial Measures**

<b>Reference:</b> <b>BP4 006</b>	<b>Title of Project:</b>	<b>Norway's RV32 Vision Zero Motorcycle Road</b>
<b>Version:</b> <b>1</b>	<b>Website:</b>	FEMA article: <a href="http://www.fema.ridersrights.org/?start_from=9&amp;ucat=&amp;archive=&amp;subaction=&amp;id=&amp;">http://www.fema.ridersrights.org/?start_from=9&amp;ucat=&amp;archive=&amp;subaction=&amp;id=&amp;</a>
<b>Brief Description of Project:</b>	<p>In May 2008 Norway opened what it described as a 'Vision Zero Motorcycle Road'. The route is approximately 15km long and measures were introduced to demonstrate the feasibility of producing a 'motorcycle friendly' road.</p> <p>Measures include the extensive re-modification of guard rail to include an under-run rail and 'soft' terminal arrangements to protect motorcyclists.</p> <div data-bbox="396 1104 919 1499" data-label="Image"> </div> <p>Lamp columns were moved away from the highway edge and behind the barrier where possible. Sign posts were replaced with 'lattix' type frangible constructions.</p> <p>Rocks were moved back from the highway edge, run-off areas were created and un-surfaced side roads were asphalted at junctions to r

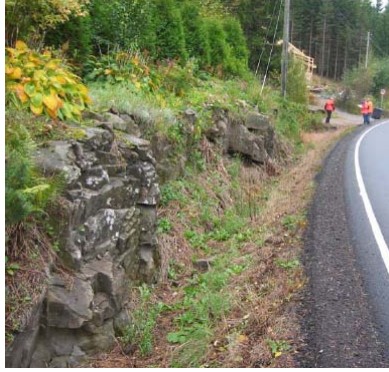
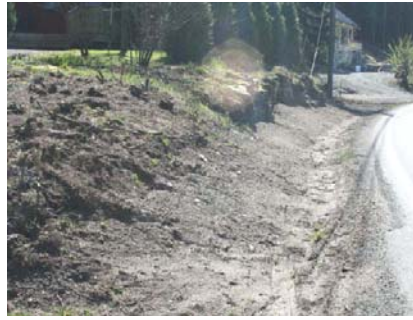
The photographs above illustrate before modification on the left and after modification on the right.

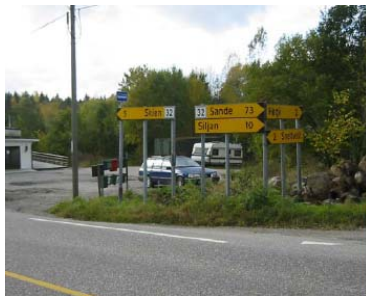
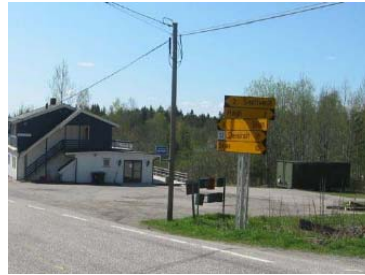
The above photographs show how several sign poles have been replaced by one 'lattix' type frangible construction. However the telegraph pole appears to remain a hazard and there seems to be little data on the performance of a 'lattix' pole when struck by a human body.
